# Navajo Abandoned Uranium Mine

# Site Screen Report

Mine Name: **Mitchell Mesa**Mine ID: **703**

**April 2012**

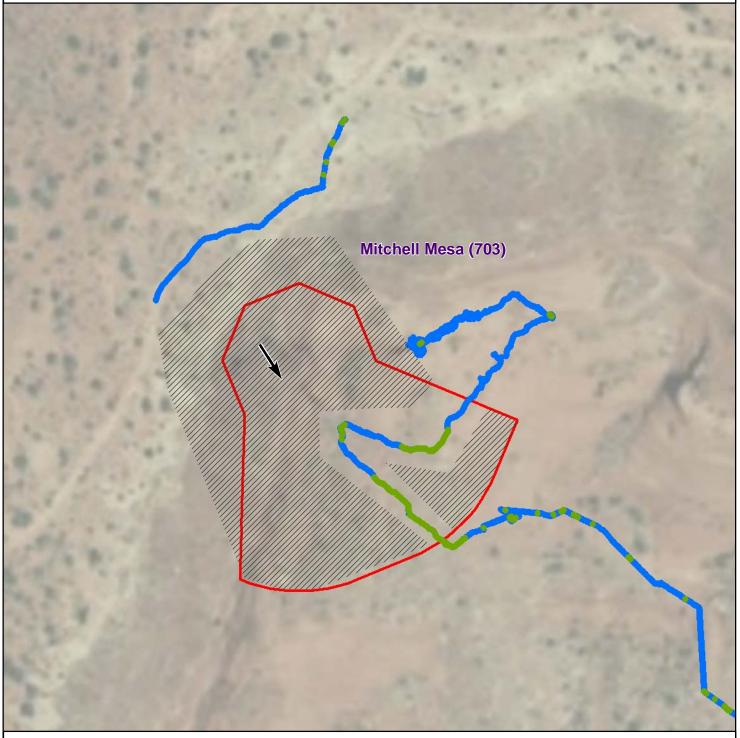
Figure 1 - Gamma Radiation Measurements, Above Two Times Background
Mitchell Mesa (703)
Oljato Chapter, Navajo Nation

A total of 2,329 gamma radiation measurements were collected from the mine site, ranging from 4,968 cpm to 14,347 cpm. The measurements are represented in Figures 1 and 2.
